Bond Street Beach Water Quality Report

April 18th, 2021

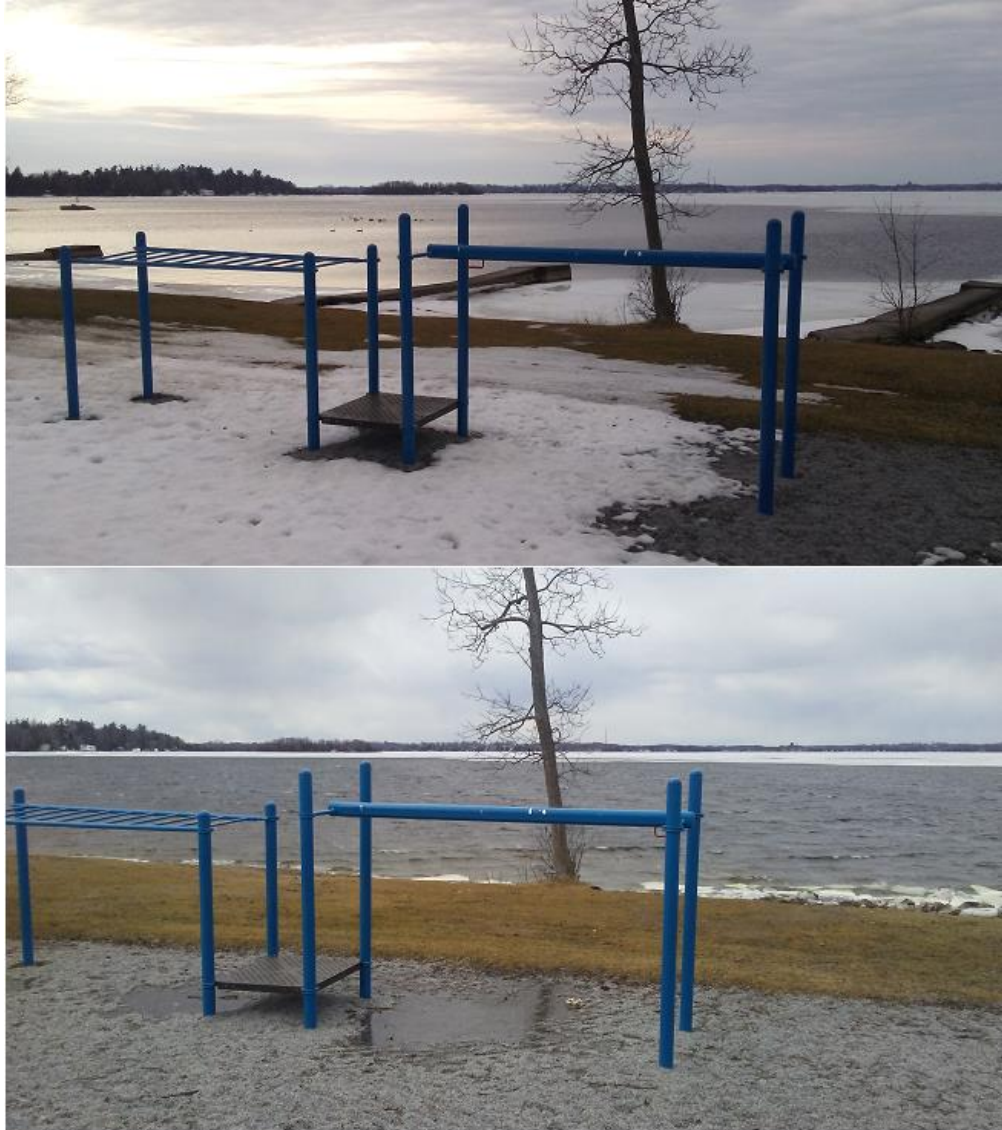
Figure 1. Site photos of Bond St. Beach prior (top) and after (bottom) the removal of the concrete piers.

- Investigate the effects of the removed concrete piers on *E. coli* densities, i.e., compare pre and post-removal *E. coli* densities.

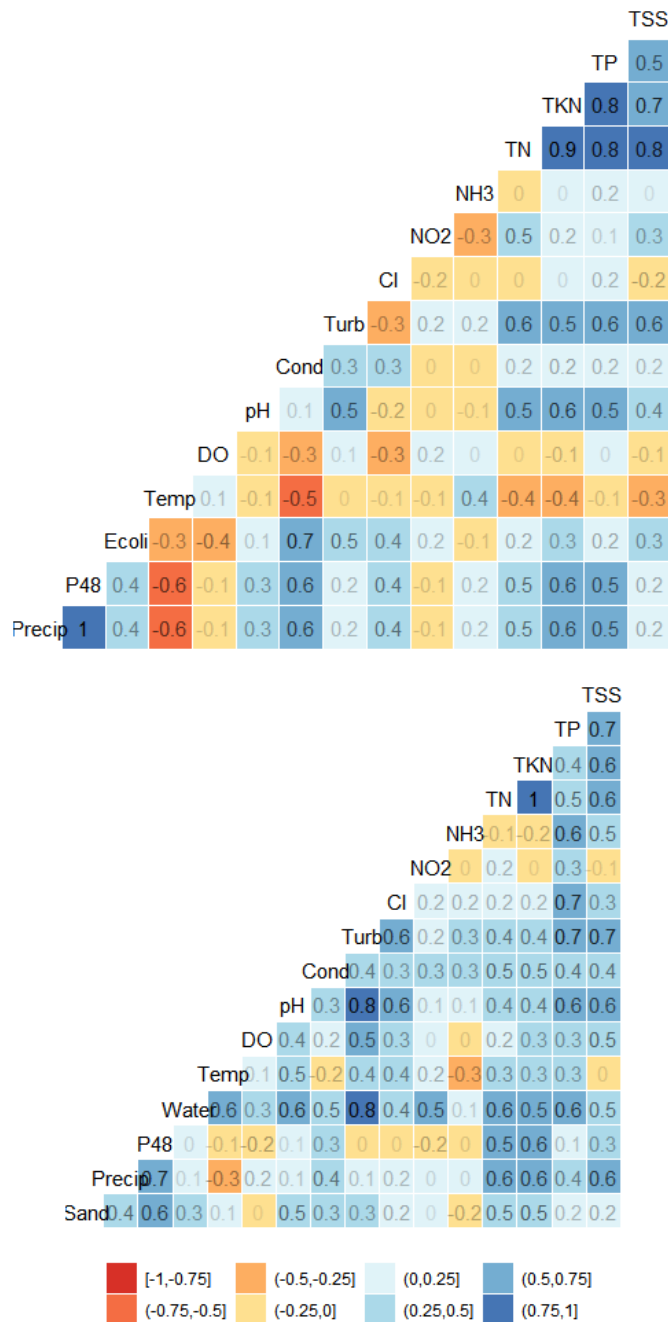
Figure 8. Correlation (relationships) between selected physical, chemical and microbiological parameters of surface water samples (Top) and with sediment samples (Bottom). Precipitation of the day of (“Precip”; a 24hrs period) and 48 hrs prior (P48) was also included. Correlation values are depicted as values between -1 (redder; negative correlated) and 1 (bluer; positively correlated). Lower coefficients (weaker relationships; <0.5) are less opaque than those of higher coefficient values (stronger relationship; >0.8).

While it is known that phosphorus tends to bind to soil particles, the weak relationship between TP-TSS ($\rho=0.5$; Figure 8 Top) is expected as Cameron Lake is classified as oligotrophic (Kawartha Conservation, 2015).

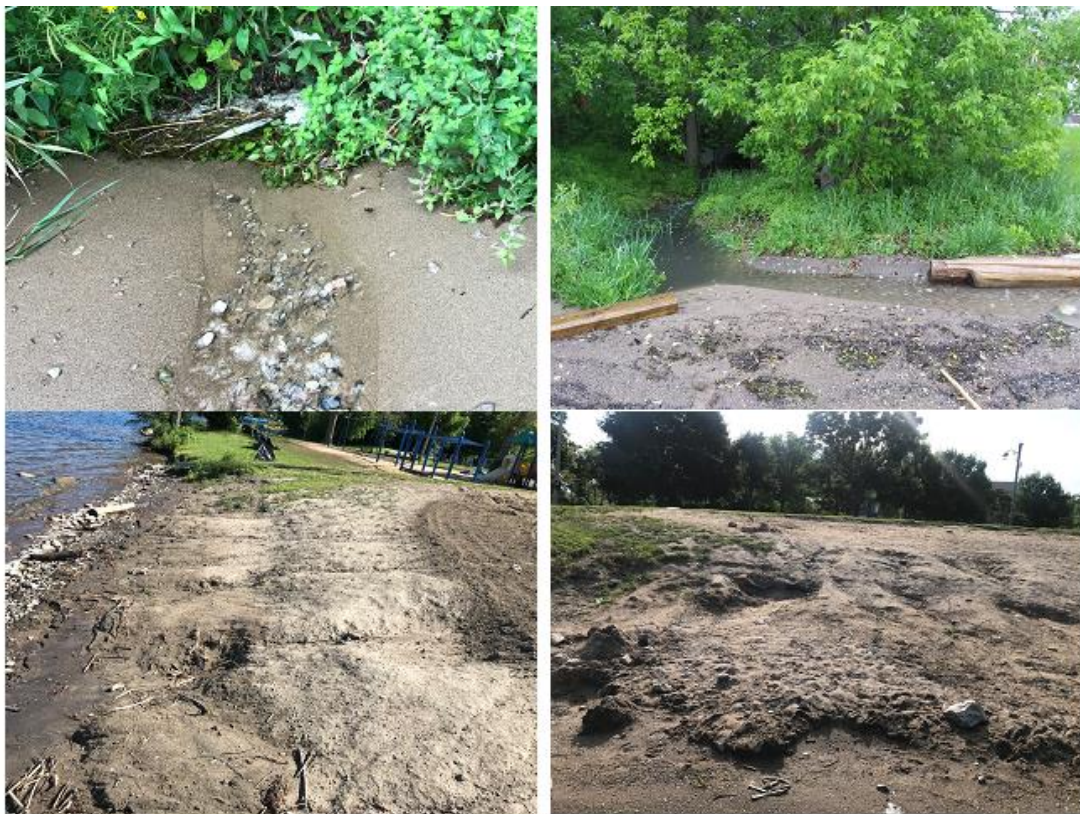
Figure 9. Stormwater runoff and channelization at Bond St. Beach.

Water conductivity measures the ability of the water to conduct electricity and is influenced by the amount of dissolved salts in the water. Conductivity ranged from 119.8 to 168.4 µS/cm (Table 2). Mean and median values were calculated at 146.61 µS/cm and 146.60 µS/cm (Table 2) and are within the range found by Kawartha Conservation (2015). When compared between sites (only using weekly data), there was a significant different (Dunn's z test = -2.27, $p=0.01$) between sites BABA and BSBC (Figure 4). This suggest that there are an influence of dissolved salts at BSBC, which could originate from the parking lot (site BSBC is closer to the roadway and parking lot; Figure 2), and/or stormwater discharge (Figure 9).

- Extend the beach grooming area to cover the lower section of the beach (Figure 9).

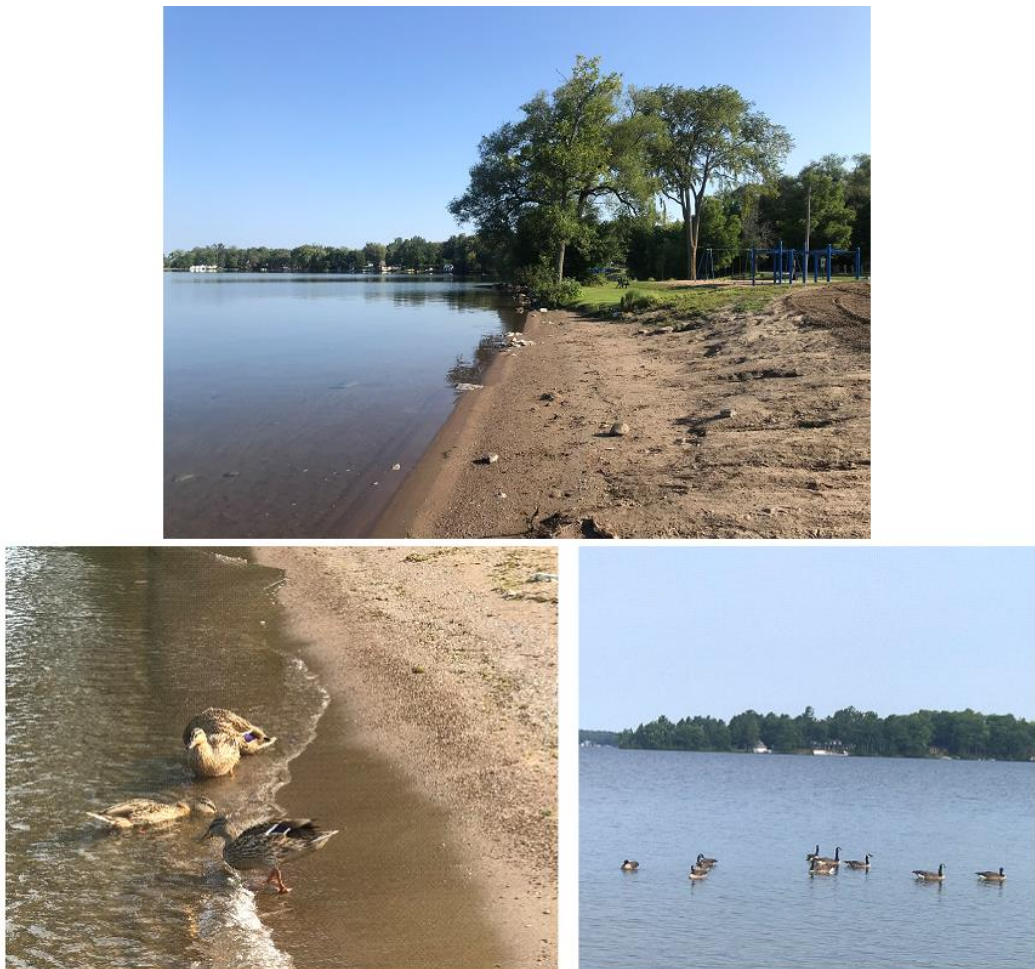
Figure 10. Depiction of the extent of beach grooming (Top) and the present of waterfowl species found (Bottom).

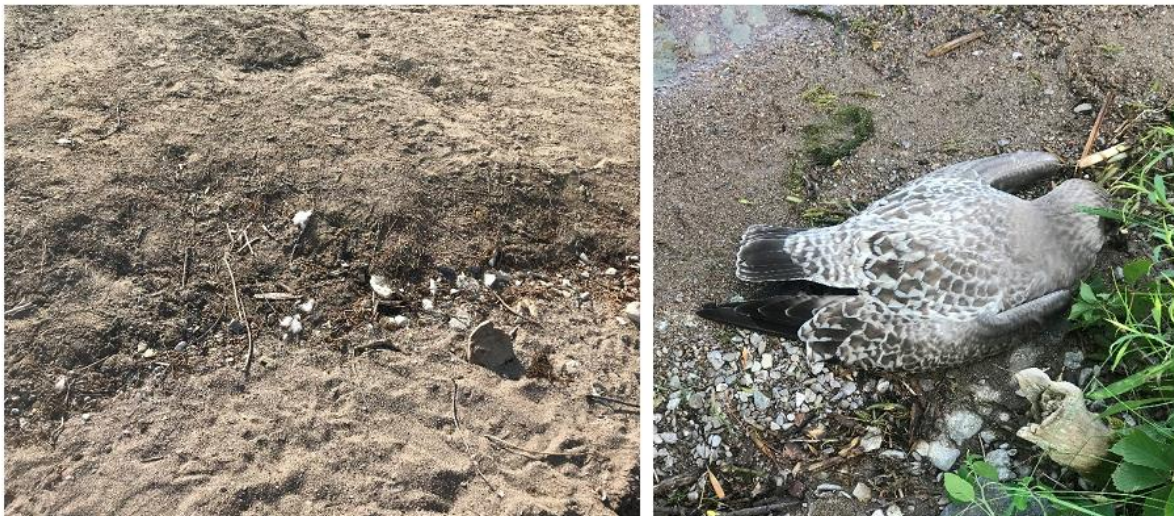
Figure 11. Portraying the common (left) and uncommon (right) types of litter found at Bond St. Beach.
