Bobcaygeon Tributary Flood Plain Map City of Kawartha Lakes Printed: July 2019

- 7) This map is prepared for use in conjunction with the Flood Plain Mapping Study Dunsford Creek, 2018.

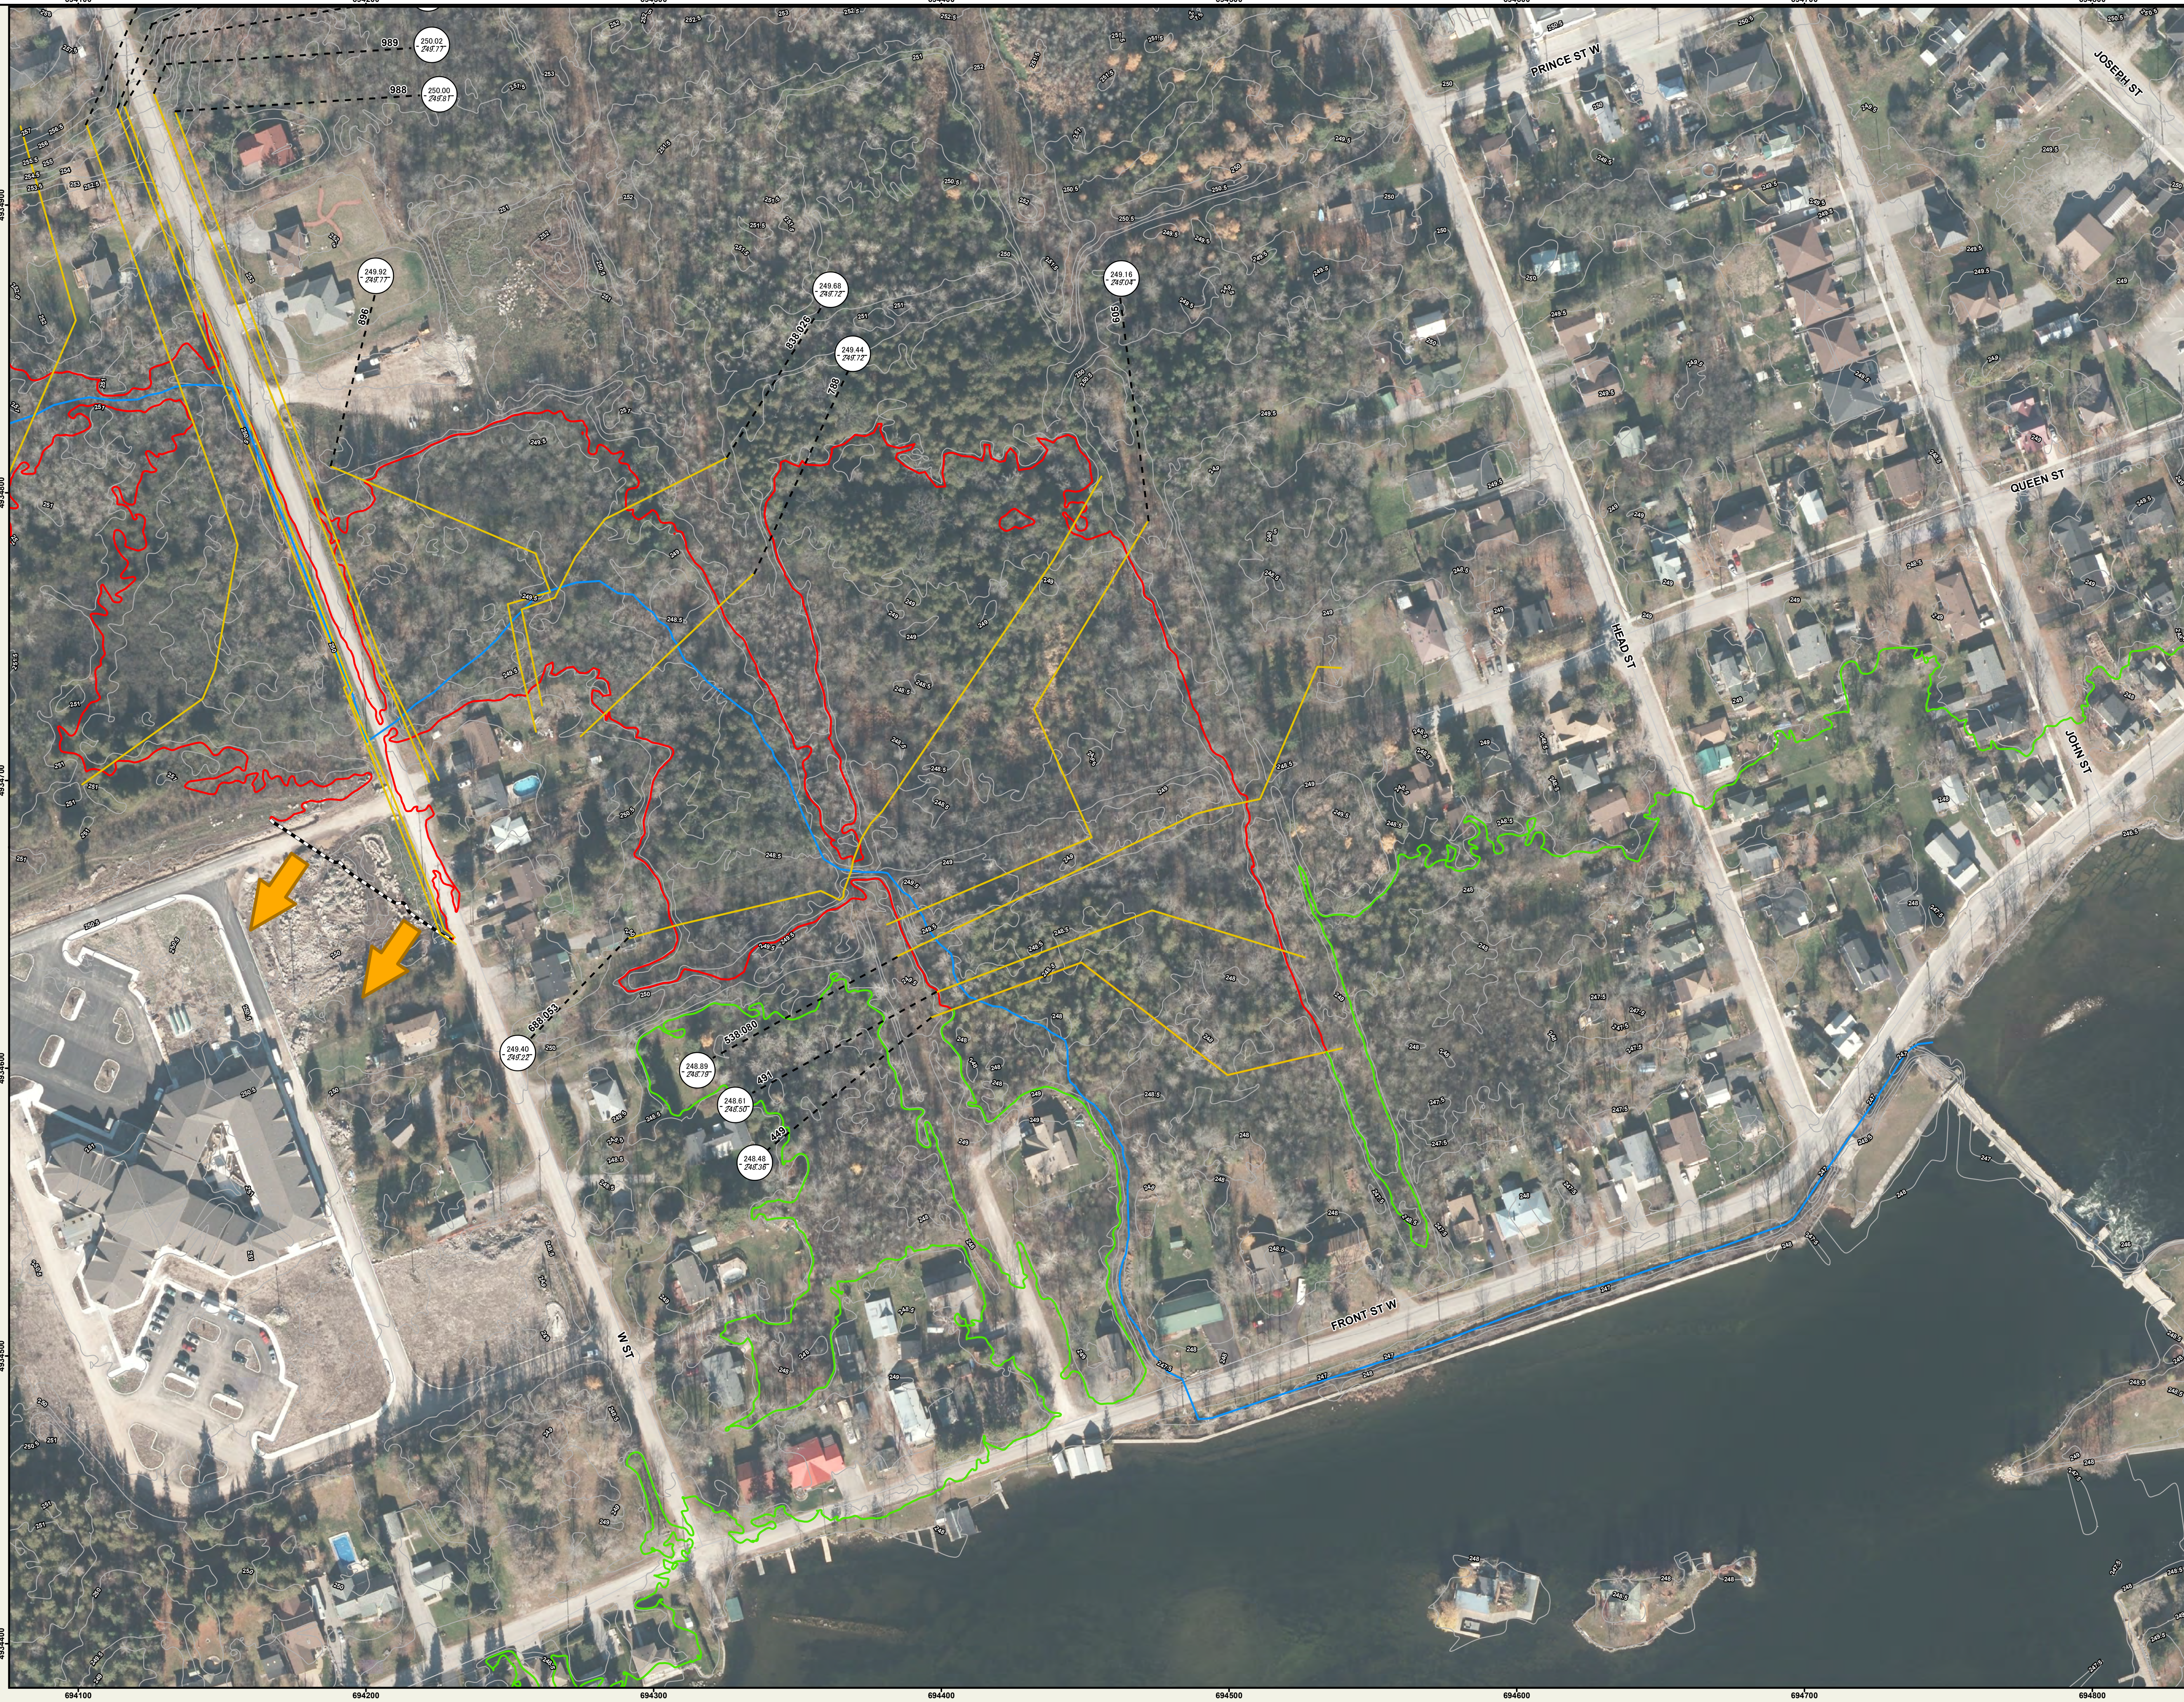
- Legend**
- Main Channel
 - Cross Section
 - 1.0 m LIDAR Contours
 - Sturgeon Lake 100yr Lake Level - 248.4m
 - Bobcaygeon Flood Plain
 - General Spill Direction
 - - - Spill Line

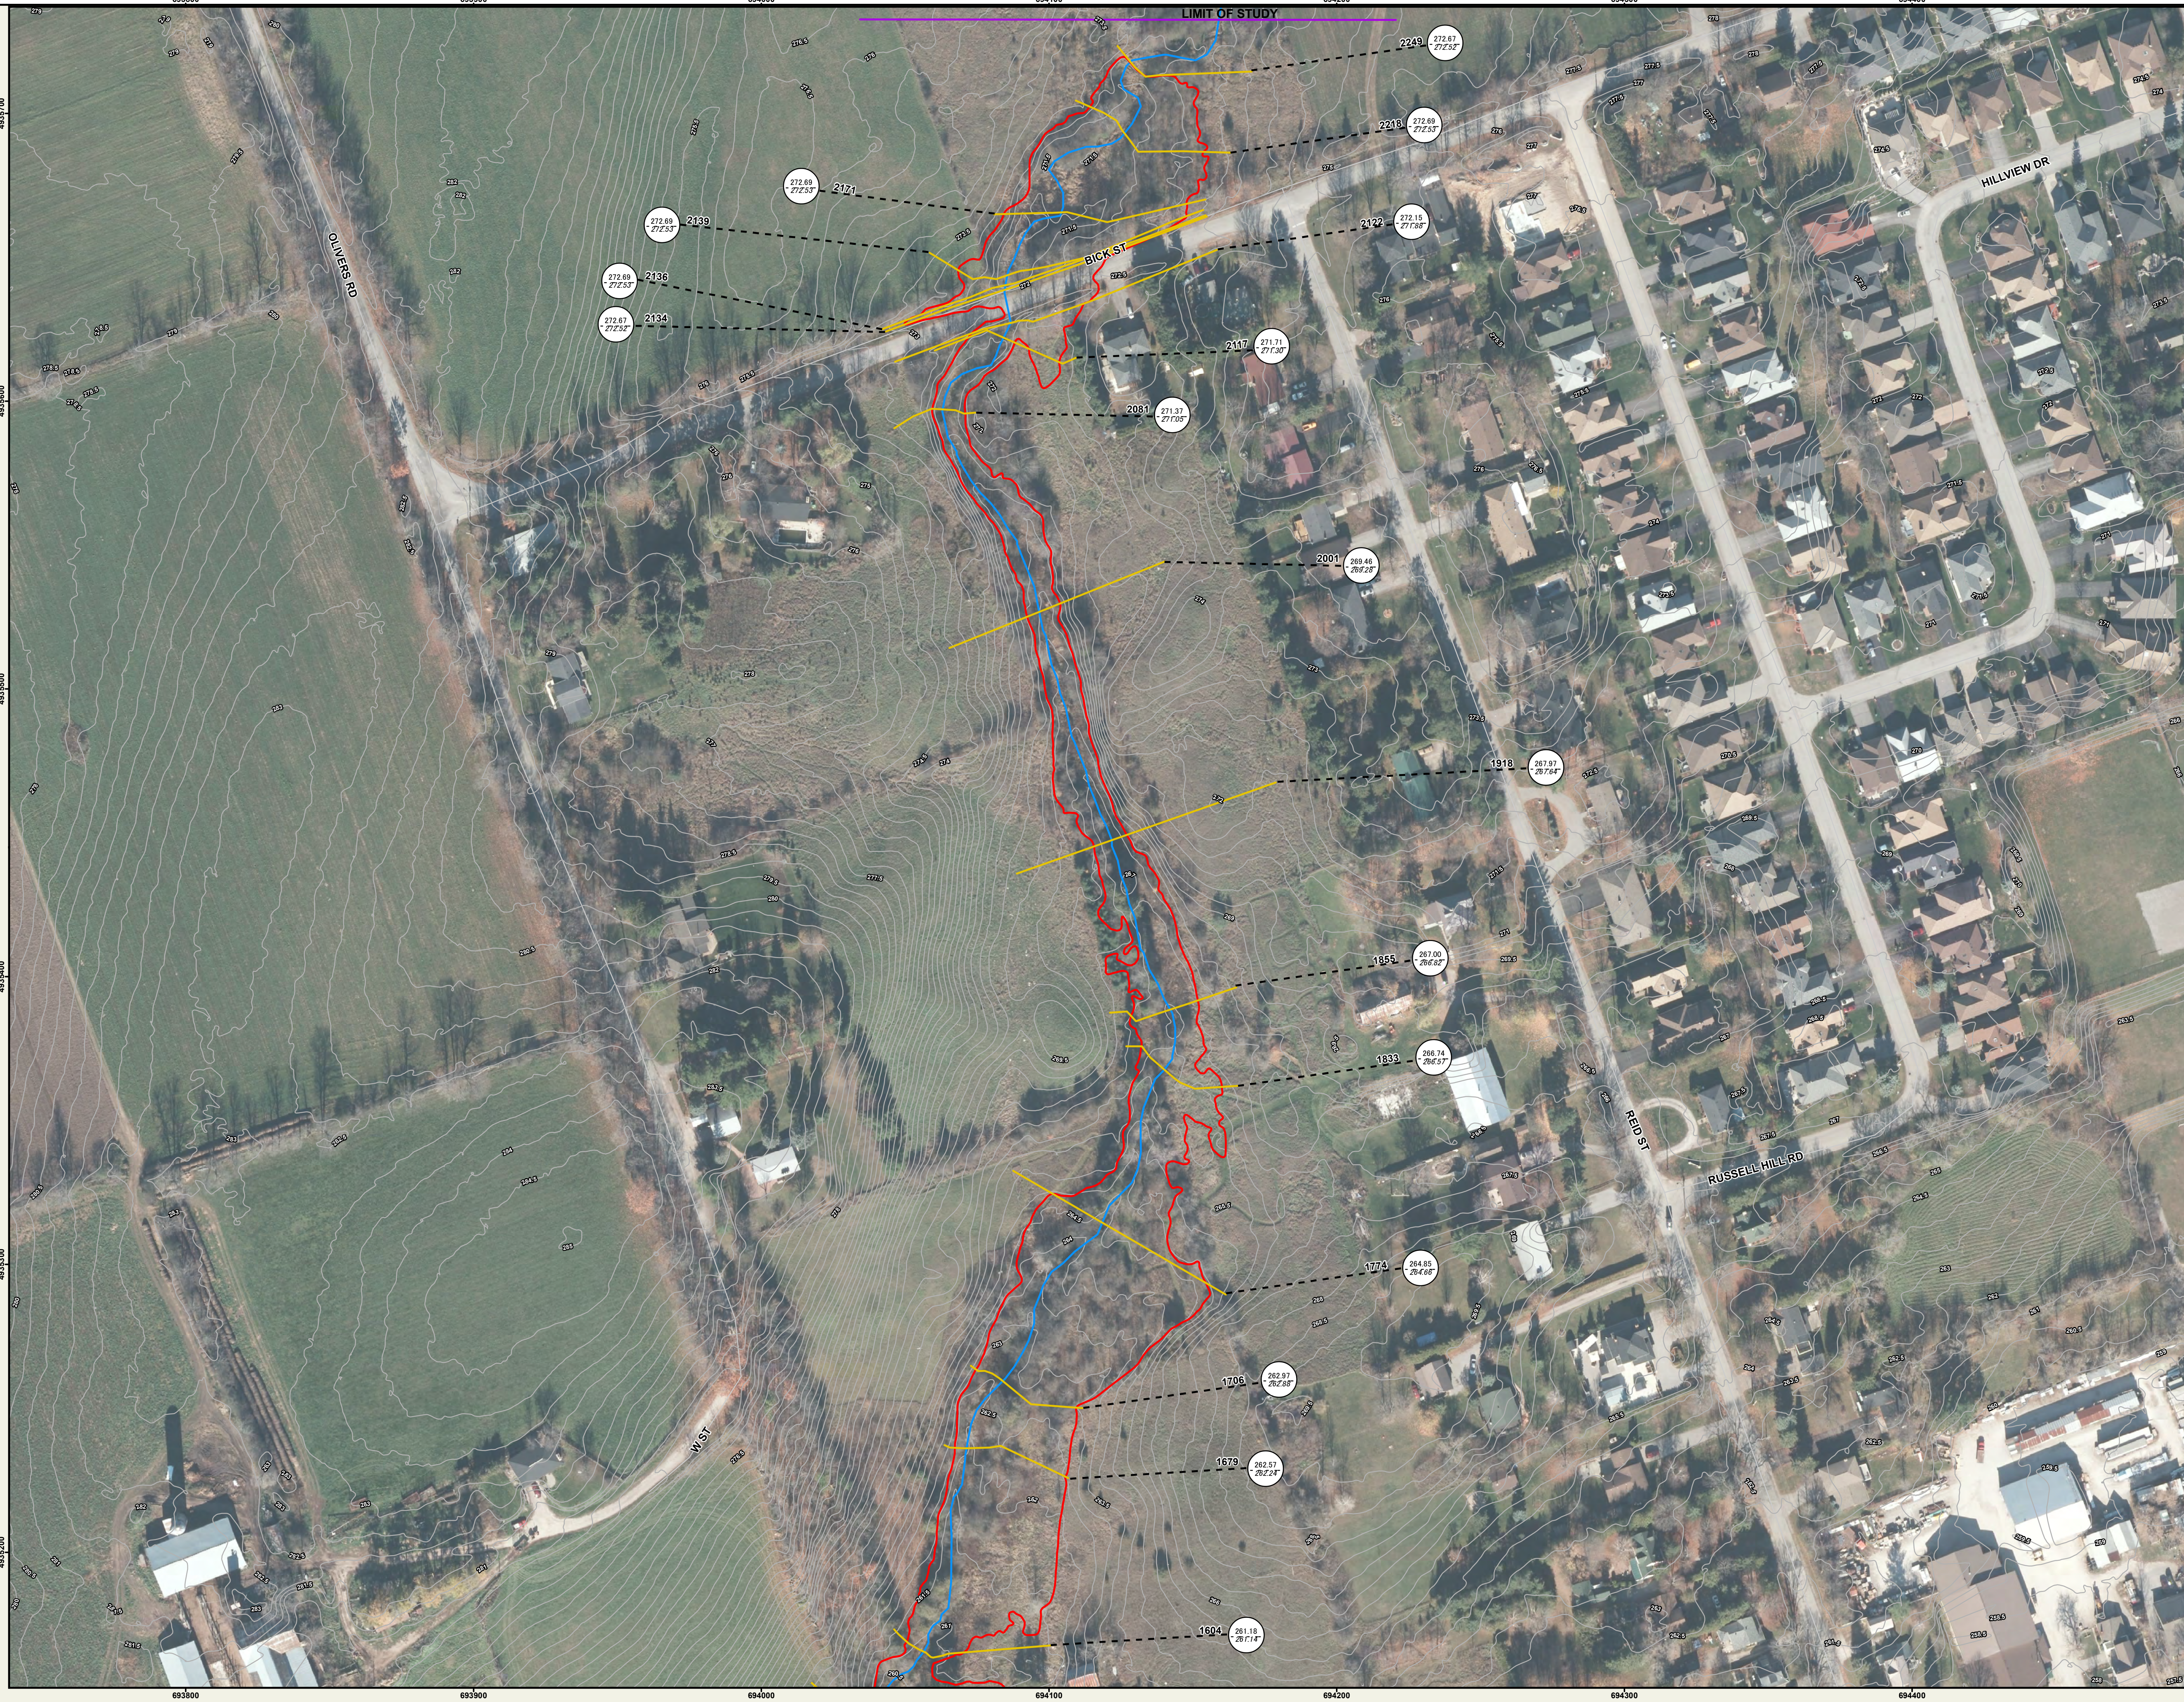
Bobcaygeon
Tributary Flood Plain Map
City of Kawartha Lakes
Printed: July 2019

- SCOPP 2013 Copyright Queen's Printer 2013.
- 5) The flood inundation areas were delineated using the DEM derived from LiDAR by Kawartha Conservation's GIS department.

- 6) Flood plain modeling was prepared by Kawartha Conservation's engineering department. Input parameters were extracted from base mapping prepared by Kawartha Conservation's GIS department.
